Case Study | interior LightSource® LS12T

B&K Powder Coating
Milwaukee, WI

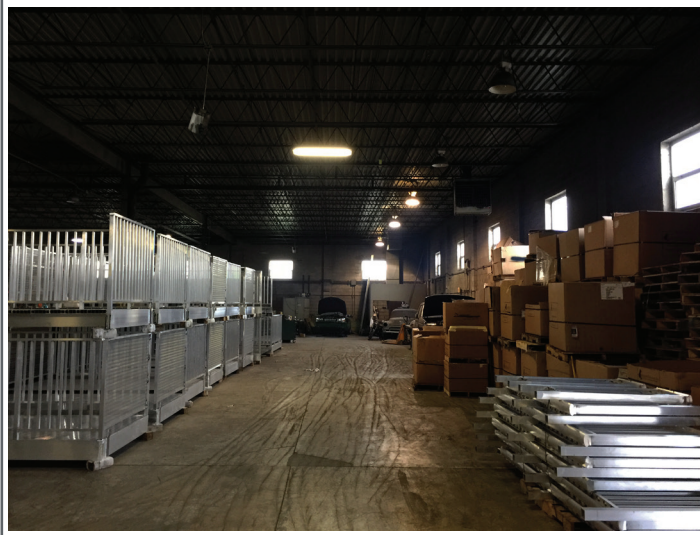
BEFORE 8 FC

Footcandles were more than tripled throughout this facility by upgrading existing HID and T8 fixtures to energy efficient energybank LED LightSource® while reducing the total number of fixtures from 27 to 20.

The consistent, even quality of the glare-free white light has dramatically improved the appearance of the space as demonstrated in the photos. High-performance LightSource delivers superior quality light for improved visual acuity. The result is an improvement in appearance, safety and performance with significant energy and maintenance savings over the next 100,000 hours of operation.
