energybank. Case Study | interior LightSource®

B&K Powder Coating
Milwaukee, WI

project data

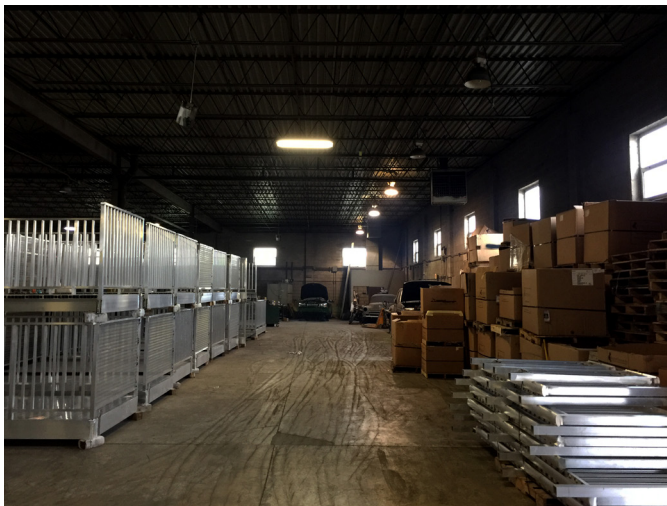
BEFORE 8 FC

Footcandles were more than tripled throughout this facility by upgrading existing HID and T8 fixtures to energy efficient energybank LED LightSource® while reducing the total number of fixtures from 27 to 20.

The consistent, even quality of the glare-free white light has dramatically improved the appearance of the space as demonstrated in the photos. High-performance LightSource delivers superior quality light for improved visual acuity. The result is an improvement in appearance, safety and performance with significant energy and maintenance savings over the next 100,000 hours of operation.

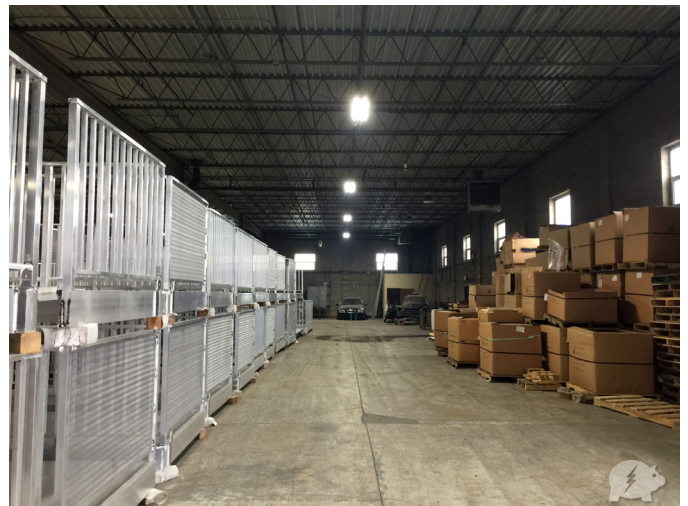
AFTER 30 FC
